**AIRCRAFT ACCIDENT AND INCIDENT  
INVESTIGATION AND PREVENTION BUREAU  
(AIB GHANA)**

**FINAL REPORT ON ACCIDENT INVOLVING SKY  
ARROW 650T MICROLIGHT AIRCRAFT  
REGISTRATION 9G-ADV, WHICH OCCURRED AT  
COMMUNITY 1, TEMA**

**16<sup>TH</sup> MARCH, 2026.**

**FINAL AIRCRAFT ACCIDENT REPORT  
AIB/2026/03/16/ACCID**

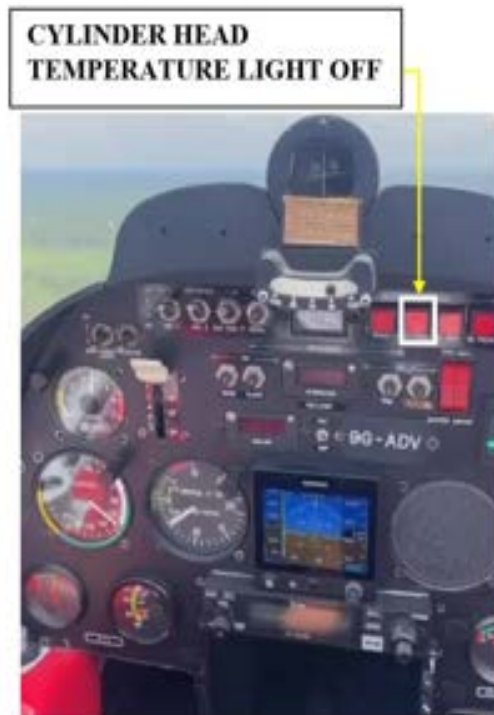
FIG 4: NORMAL CONDITIONS OBSERVED IN-FLIGHT WITH FRIEND AT DGAAH ON 16TH MARCH 2026

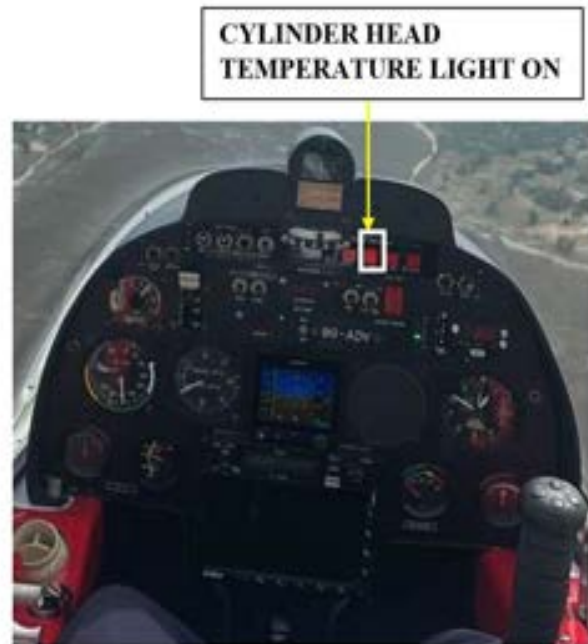
FIG 5: ABNORMAL CONDITIONS OBSERVED IN-FLIGHT AT 1432 UTC ON DGAAH - DGAA FLIGHT ON 16TH MARCH 2026

Based on the engine related malfunctions at DGAH, the engine overheating history, the picture of the aircraft engine instruments indicating overheating of the Cylinder Head in flight twenty-five (25) minutes prior to the accident and the sudden loss of height prior to the crash, the investigation has determined that the engine most likely failed during the subject flight.

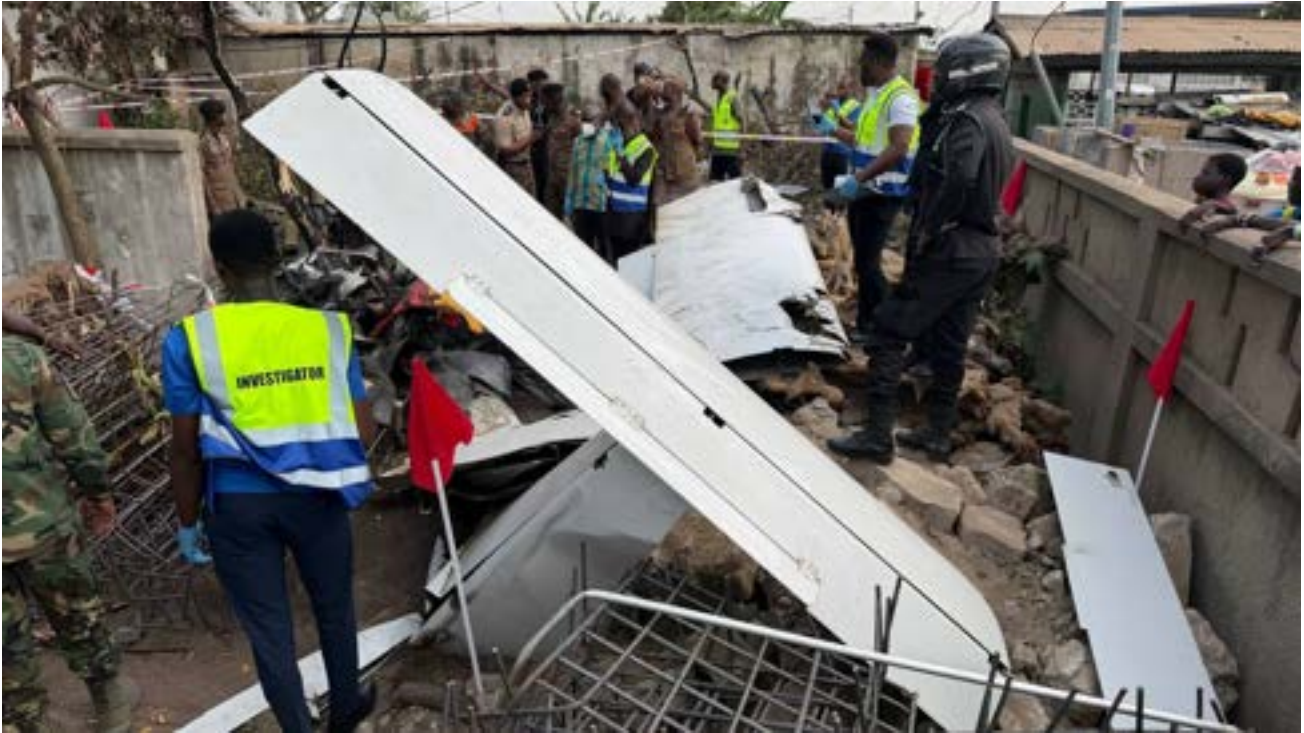
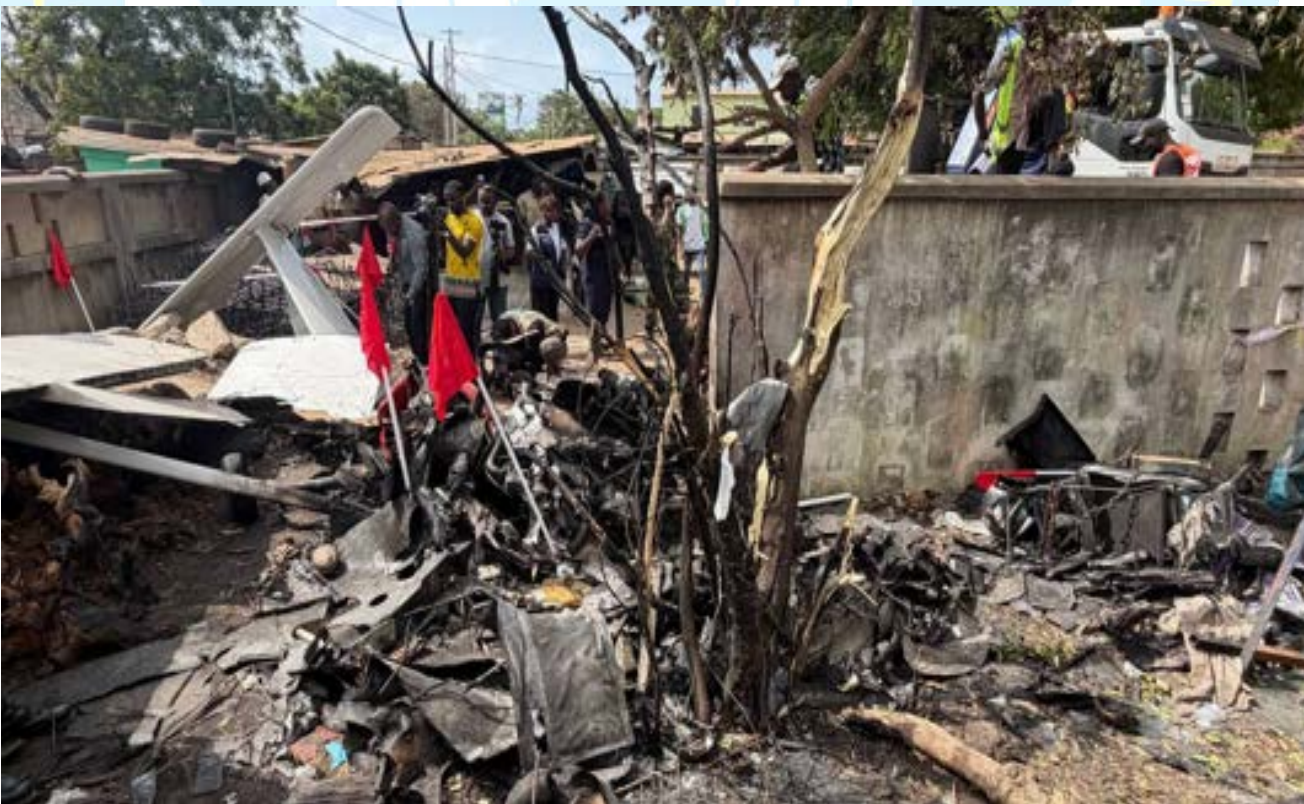
APPENDIX 16: PICTURES OF ACCIDENT SITE

The final flight path of the aircraft passed by several trees before clipping part of the roof of the Day Care Centre and finally impacting a single tree at a dumpsite located between two of the Day Care buildings which had a plastic water tank on site. The site was a confined space with a walled perimeter fence. The impact was immediately followed by a post-crash fire, which engulfed the aircraft. Emergency response personnel arrived at the scene and successfully extinguished the fire. The fire was contained in a timely manner, which limited further damage to the surrounding area, although the aircraft was destroyed. The occupants were recovered from the wreckage with fatal injuries.

The aircraft impacted within the premises of TMA Day Care School, Community 1, Tema, resulting in damage to portions of the school grounds and surrounding property.

The post-impact fire caused localized burning of surface materials within the immediate crash site. There was also damage to part of the roofing of the school building.

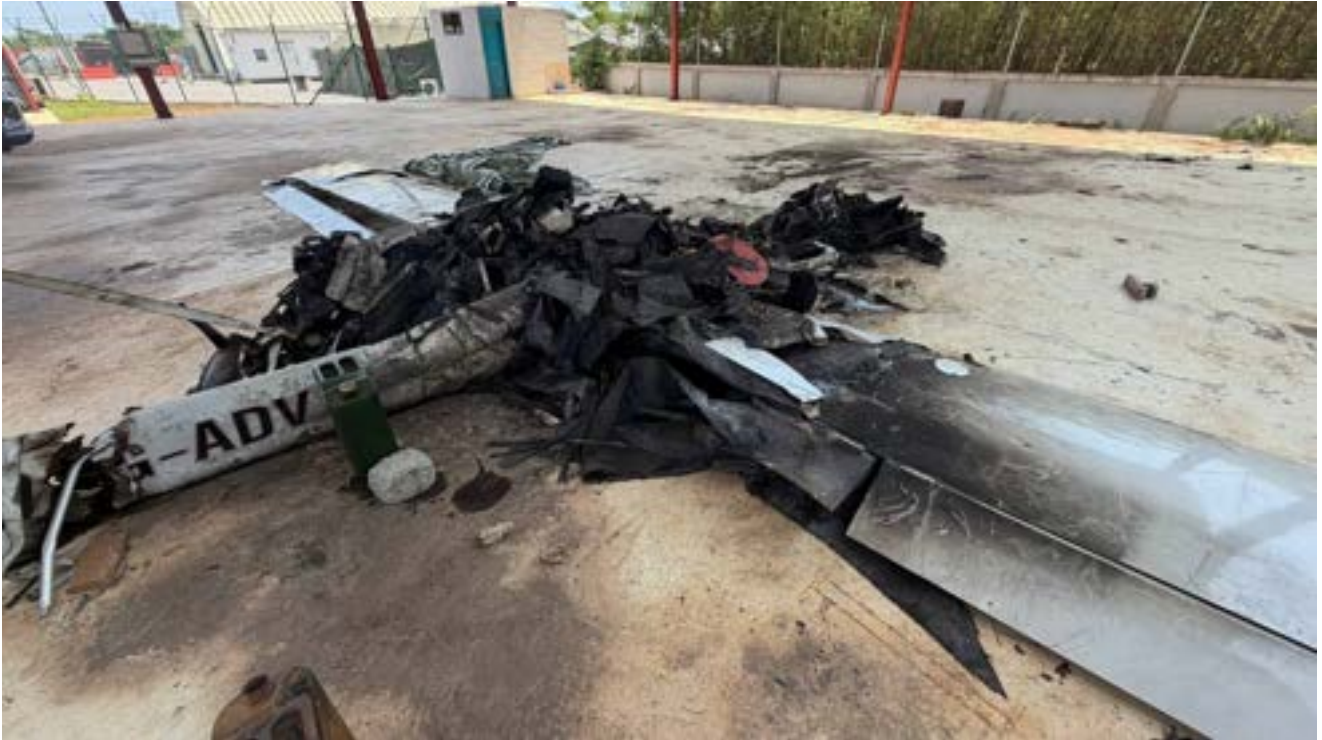
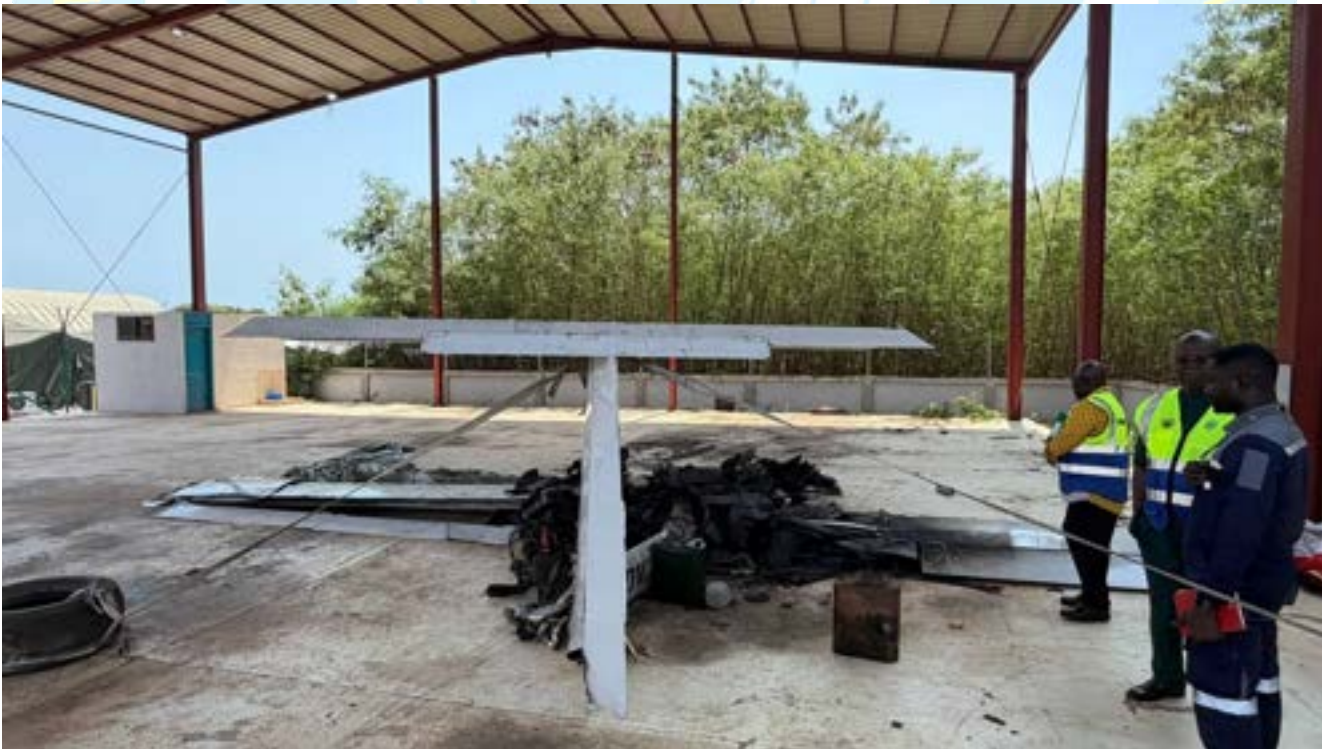
APPENDIX 17: PICTURES OF WRECKAGE

The aircraft was destroyed as a result of the impact and subsequent post-crash fire. The aircraft sustained severe structural damage upon ground impact, followed by an intense fire that consumed significant portions of the airframe, the engine and the propellers. The extent of deformation, fragmentation, and fire damage to the fuselage, and associated systems was such that the aircraft was rendered beyond economical repair.
