1. FACTUAL INFORMATION

1.1 *History of the flight*

On 2nd June, 2012 at 1828hrs Allied Air Ltd Flight DHV 111, a Boeing 727-221 Cargo aircraft, Registration: 5N-BJN, departed Murtala Muhammed International Airport, Ikeja, Lagos-Nigeria to Kotoka International Airport, estimating Accra, Ghana at 1904hrs, en-route to Abidjan. While taxiing for take-off, the Flight Engineer observed that the CSD amber light (caution) had illuminated on the panel. With the Captain's permission, it was disconnected.

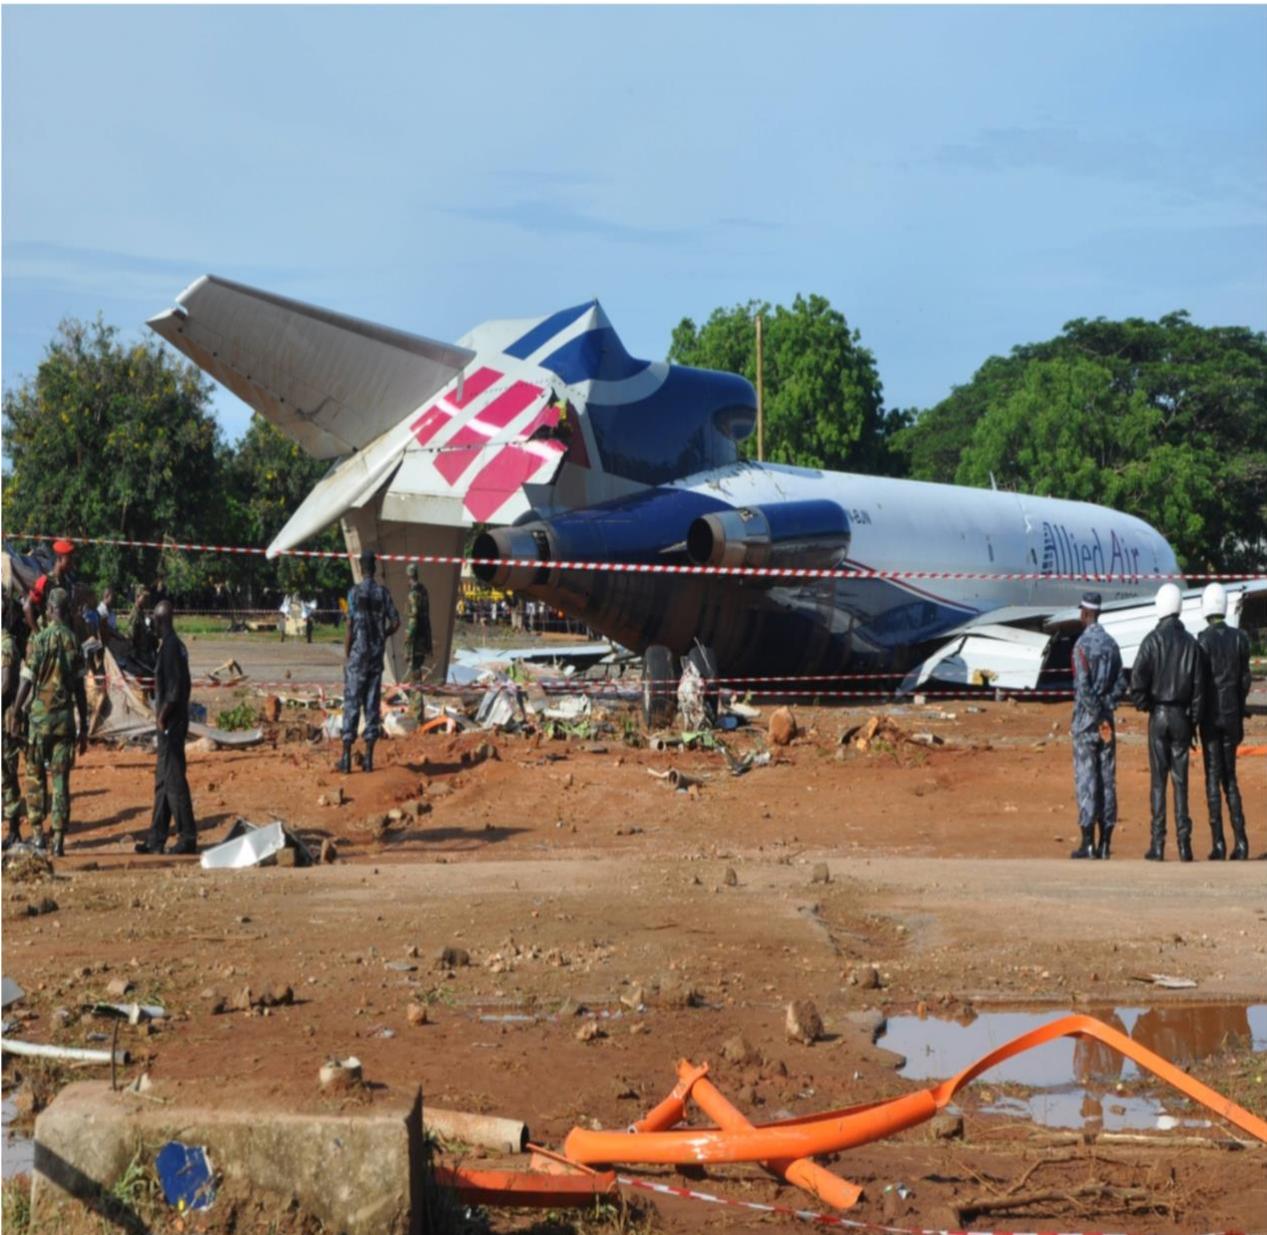
The aircraft came to a rest outside the airport perimeter wall 1171ft (350m) from the Threshold of Runway 03, heading 215° southwest, coordinates 05 35 13.67N 000° 10 29.20W.

Figure 1 Photograph of the accident aircraft in the rest position.

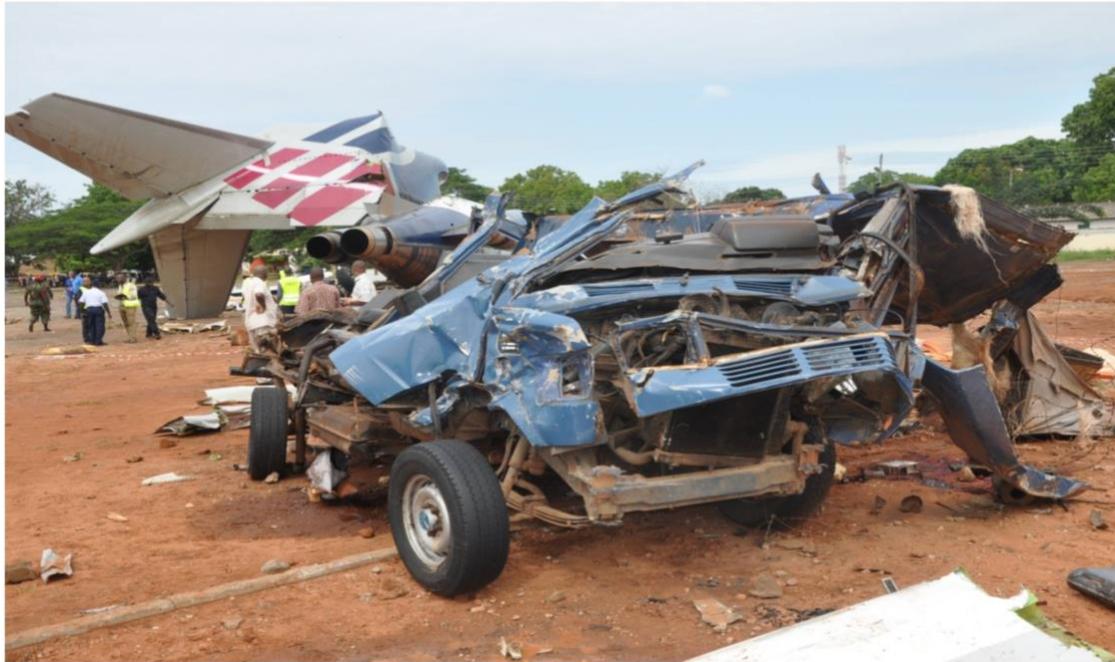
Figure 3 Photograph of the crashed minibus within the accident vicinity.

The left landing gear and wing flattened the mini bus. In the process about $\frac{1}{3}$ of the wing housing the fuel, broke off with fuel in the tank dripping. The landing gear twisted to rest on top of the wing. The two mounts on which the inner flaps were supported together with the screw jacks were damaged from the impact. The outer wing flaps turned in the upwards direction of the wind flow. The No.3 outer flaps were detached and found close to the flattened mini bus.

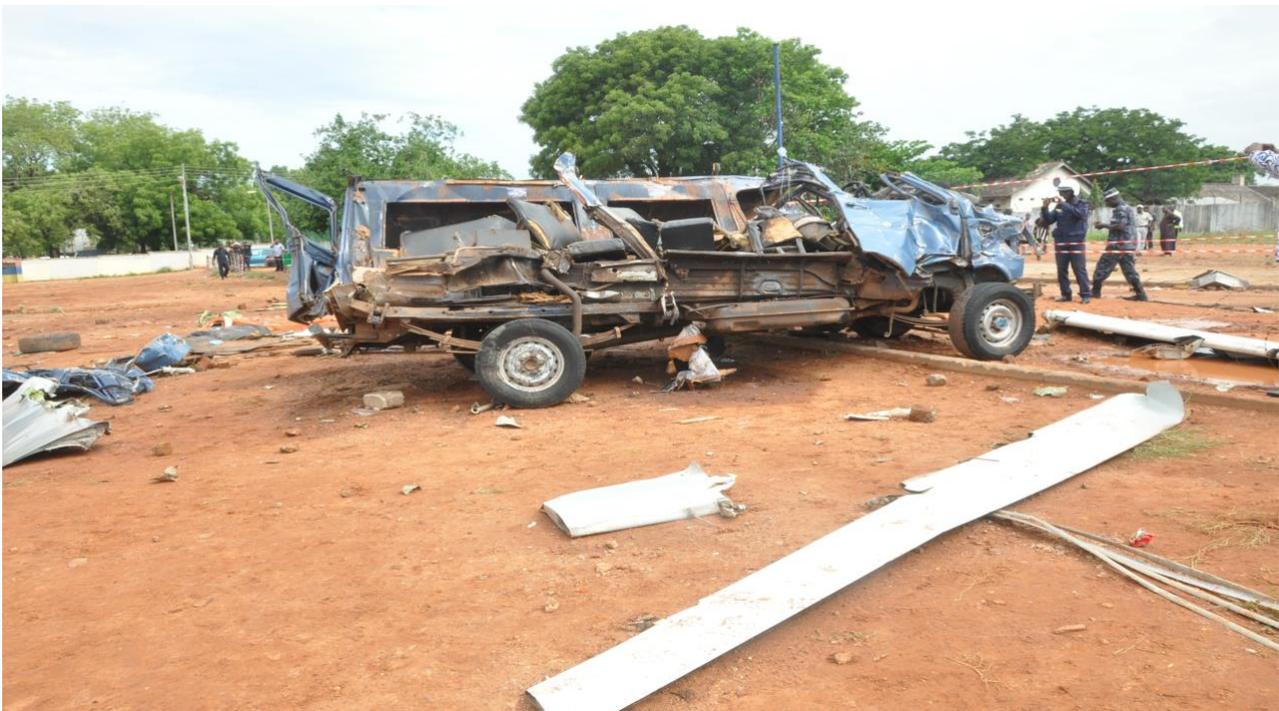
Photograph of the crashed minibus within the accident vicinity.
