**AIRCRAFT ACCIDENT AND INCIDENT  
INVESTIGATION AND PREVENTION BUREAU  
(AIB GHANA)**

**AIRCRAFT INCIDENT REPORT  
AIB/2021/09/03/INCID**

**REPORT ON THE BIRD STRIKE INCIDENT  
INVOLVING KLM FLIGHT KL 590 BOEING 777-300 ER  
AIRCRAFT WITH REGISTRATION PH-BVK ON 3<sup>RD</sup>  
SEPTEMBER, 2021 AT KOTOKA INTERNATIONAL  
AIRPORT, ACCRA, GHANA.**

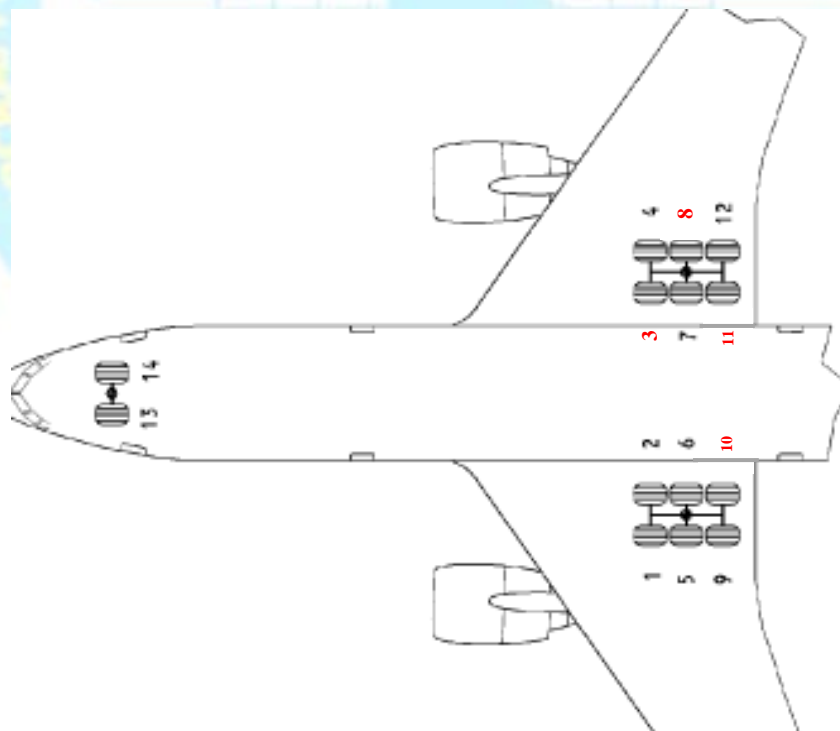
Figure 2 B777-300 ER Wheel Numbering

Subsequent inspection revealed that wheel numbers 3 and 11 had been deflated while wheel numbers 8 and 10 were worn to cords (*Figure 2 and Appendix B*).

14. ATC provided prompt and effective assistance to the flight crew.
15. Wheel numbers 3 and 11 were deflated while wheel numbers 8 and 10 were worn to cords.

High energy stop inspection was performed, axles and brakes were found to be satisfactory. Wheel numbers 3, 8, 10 and 11 were replaced followed by an independent inspection (*Appendix D*).

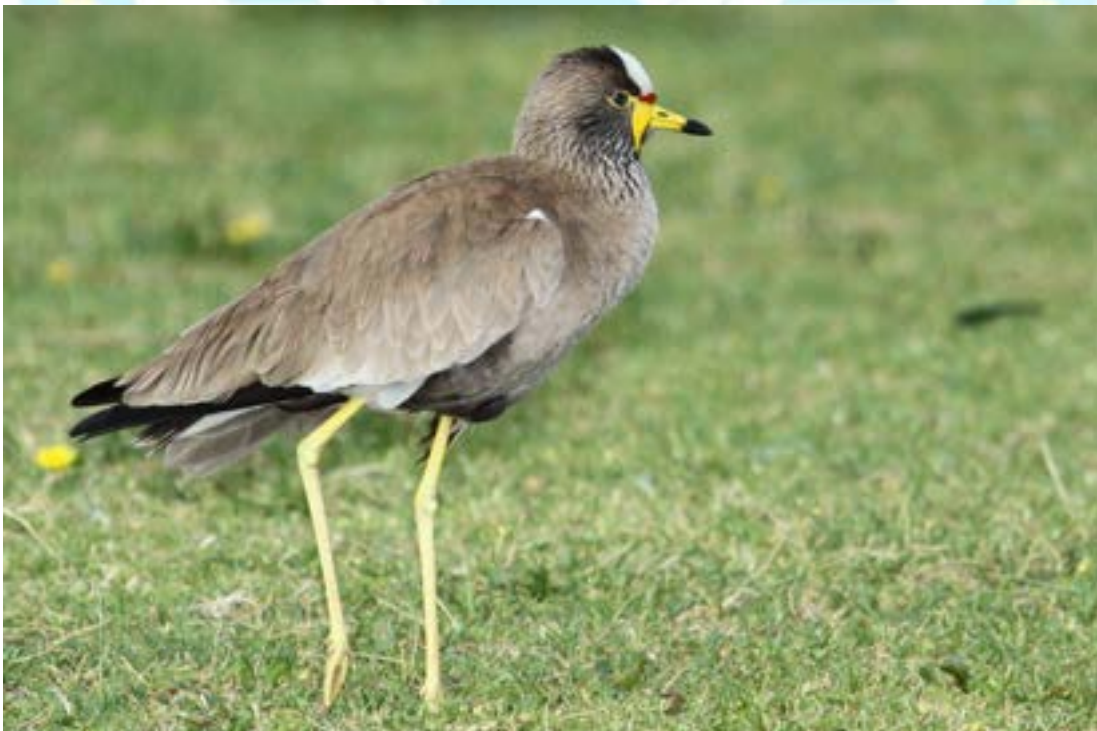
Figure 3 African Wattled Lapwing

It is evident that the African Wattled Lapwing (*Vanellus Senegallus*) was involved in the incident. The Lapwing is widespread in sub-Saharan Africa and commonly feeds at night. Records also indicate that the bird remains found after the incident on the runway were that of the African Wattled Lapwing. These birds are resident while breeding, but might move over distances during the rainy season.

The African Wattled Lapwing prefers marshes and wet grasslands. These conditions are characteristic during the rainy season in areas such as the runway shoulders. The immediate environment around the airport can contribute to the presence of the Lapwing. The diet for the African Wattled Lapwing consists almost exclusively of insects. Generally, these birds are attracted to insects which are prevalent during the rainy season.

Most bird strikes at KIA occur during the day. However, the Lapwing is known to feed at night and was the type of bird involved in the incident of the night of 3<sup>rd</sup> September, 2021.

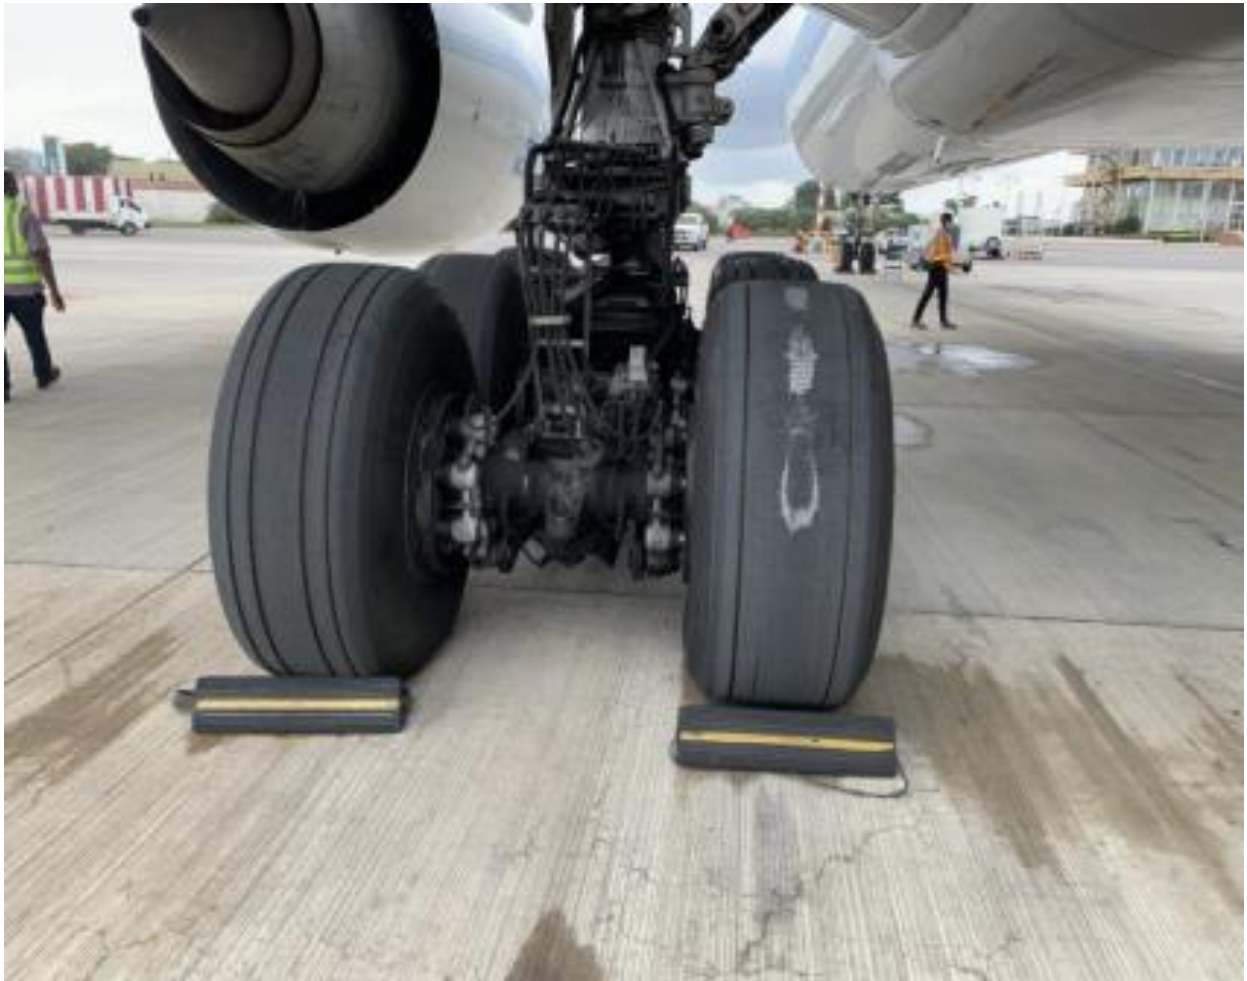
APPENDIX B: WHEELS WORN TO CORDS

There was no evidence to suggest that the aircraft had any defect or malfunction that could have affected its performance and was not a factor in the incident. The deflated and worn-out wheels occurred as a result of the RTO. Maintenance inspection procedures carried out after the incident, indicated there was no damage to the aircraft.

18. The aircraft was inspected and wheel numbers 3, 8, 10 and 11 were replaced.
19. The aircraft was released to service on 5<sup>th</sup> September 2021.

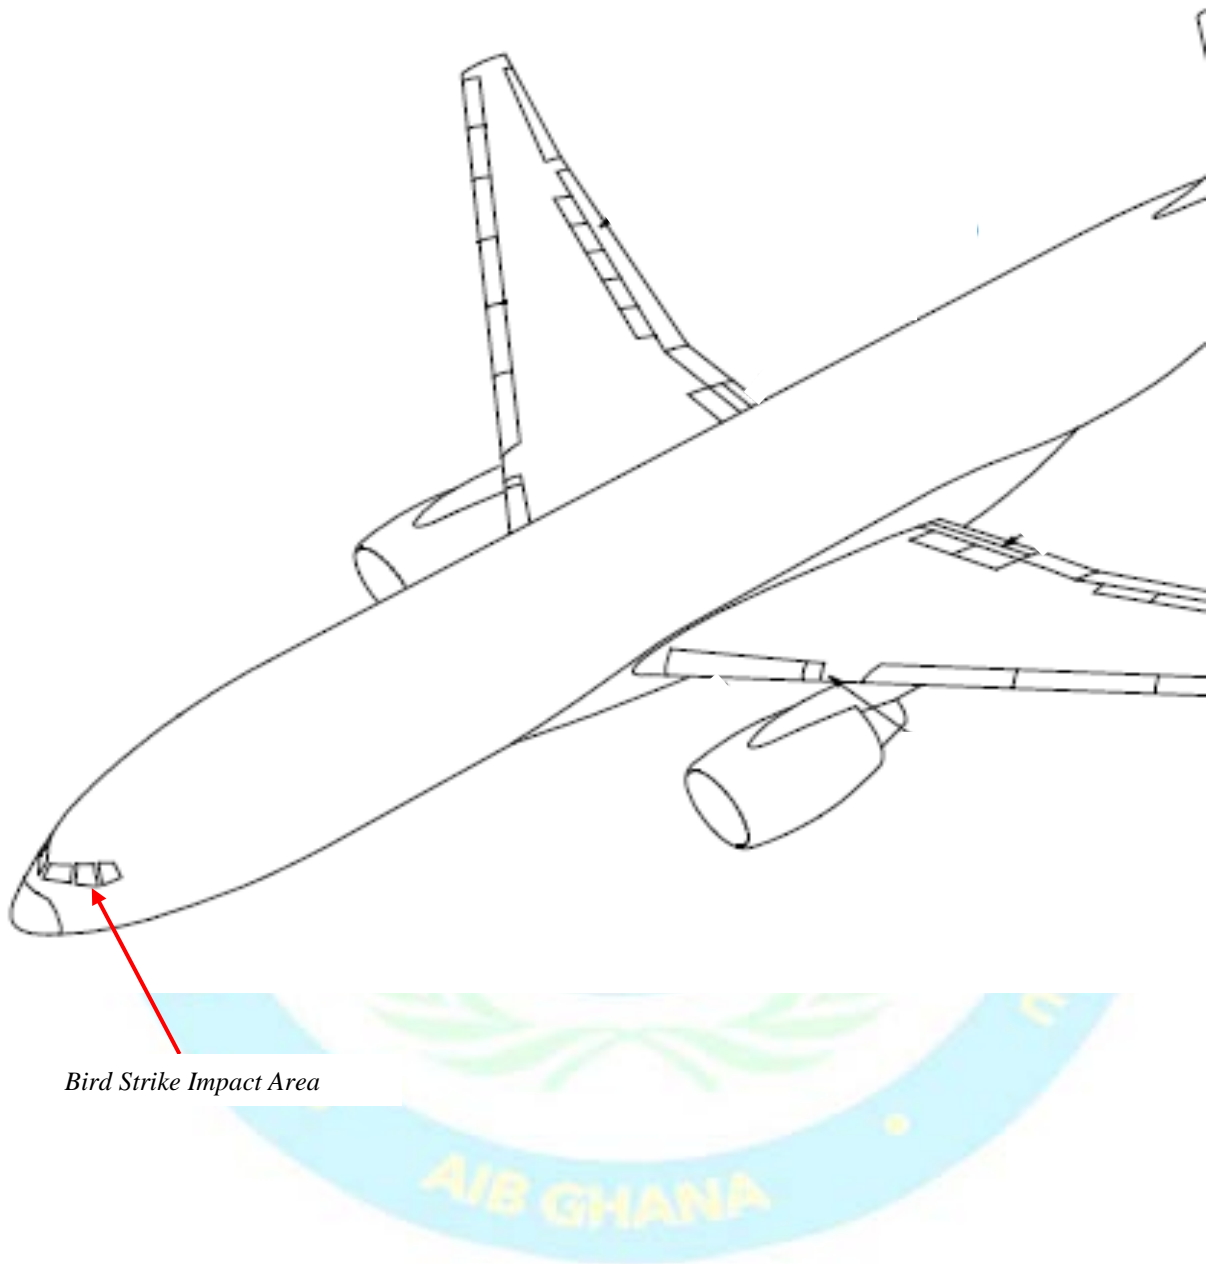
APPENDIX C: ILLUSTRATION OF BIRD STRIKE IMPACT AREA

Bird strike inspection was carried out. Bird remains were cleaned from underneath the Captain's number 2 Window (*Appendix C*) and no damage was found. Two dead African Wattled Lapwing birds were found on the runway during the mandatory runway inspection after the incident by GACL personnel.

16. Bird remains were cleaned from underneath the Captain’s number 2 Window and no damage was found on the aircraft.
17. Two dead birds were found on the runway following a mandatory runway inspection after the incident by GACL personnel.

BIRD REMAINS CLEANED AND BIRD STRIKE INSP PERF PER AMM TASK 05-51-18-210-801. NIL FURTHER DAMAGE FOUND. HIGH ENERGY STOP INSPECTION DONE PER AMM 05-51-14-210-801. AXLES AND BRAKES FOUND SATIS. WHEELS 3,11, 8 AND 10 REPLACED PER AMM TASK 32-45-01. INDEPENDENT INSPECTIONS PERF PER LPM 5.1.500. A/C SERVICEABLE AT 0010GMT 05 SEP 21. A/C DEPART AT 0145GMT 05 SEP 21.
