**AIRCRAFT ACCIDENT AND INCIDENT  
INVESTIGATION AND PREVENTION BUREAU  
(AIB GHANA)**

**REPORT ON ACCIDENT INVOLVING TRAVAUX ET  
SERVICES AERIENNES (TSA), HUMBER AVIATION  
M.D.C. 912 STA AIRCRAFT WITH REGISTRATION  
TU-LAB, AT KASUNYA - ASUTSUARE (EASTERN  
REGION) ON 17 MARCH 2022.**

**AIRCRAFT ACCIDENT REPORT  
AIB/2022/03/17/ACCID**

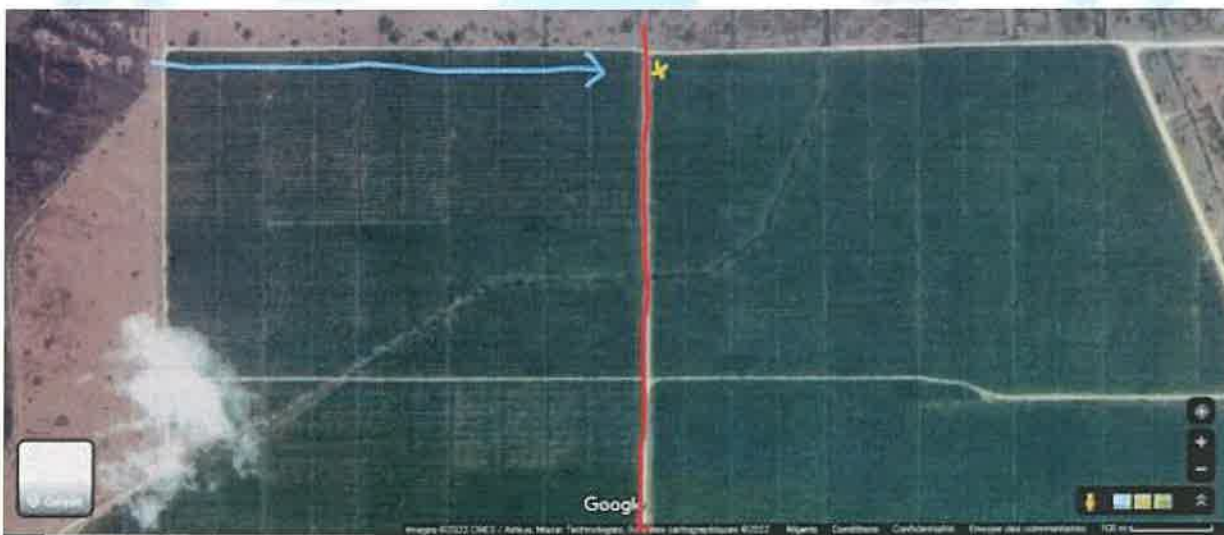
Upon the impact, the aircraft crashed in the North-West corner of the farm field (See Figure 1). The aircraft landed on its back and then caught fire.

*Figure 1: Satellite view of crash site\_ Sector 22 (D-C)(cyan line-direction of flight/red line-voltage line running along road/yellow mark-crash site)*

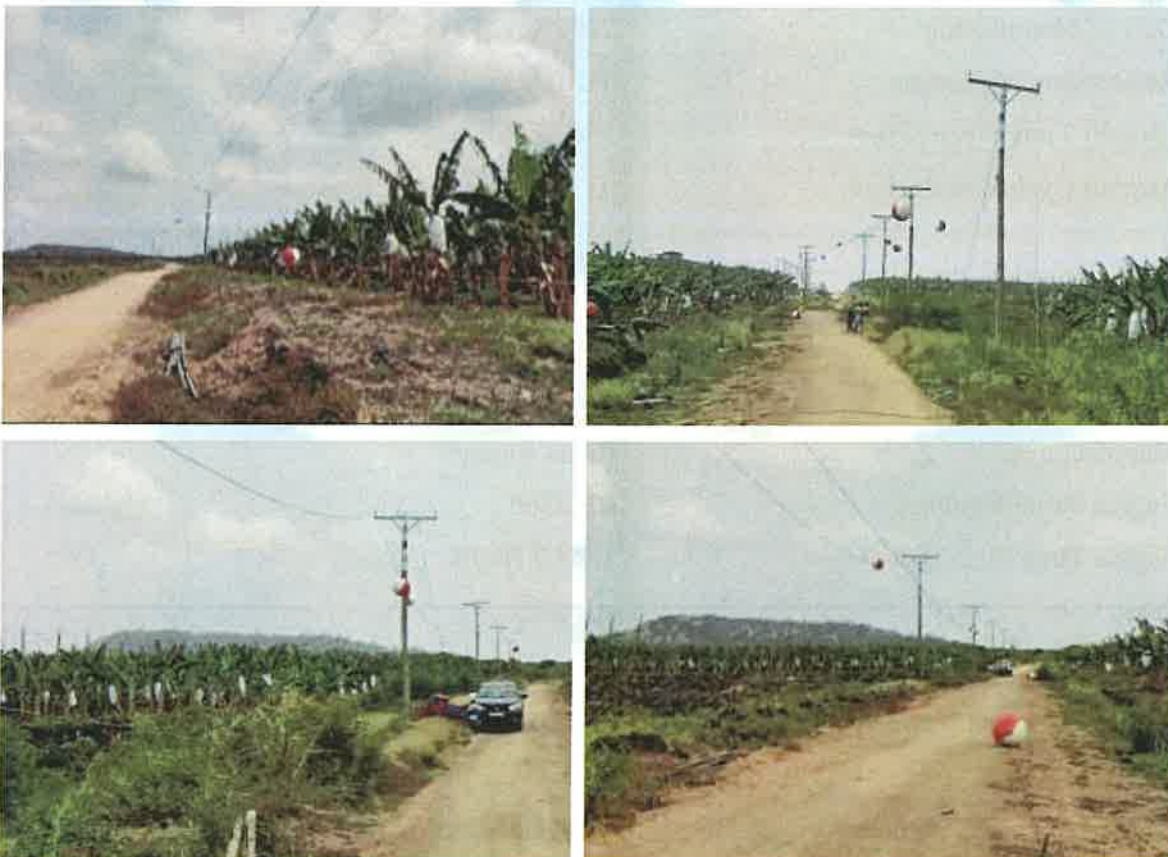
Banana trees within 8ft radius of the wreckage, farm sprinkler system and power lines were also damaged.

*Figure 2: Damaged Power line*

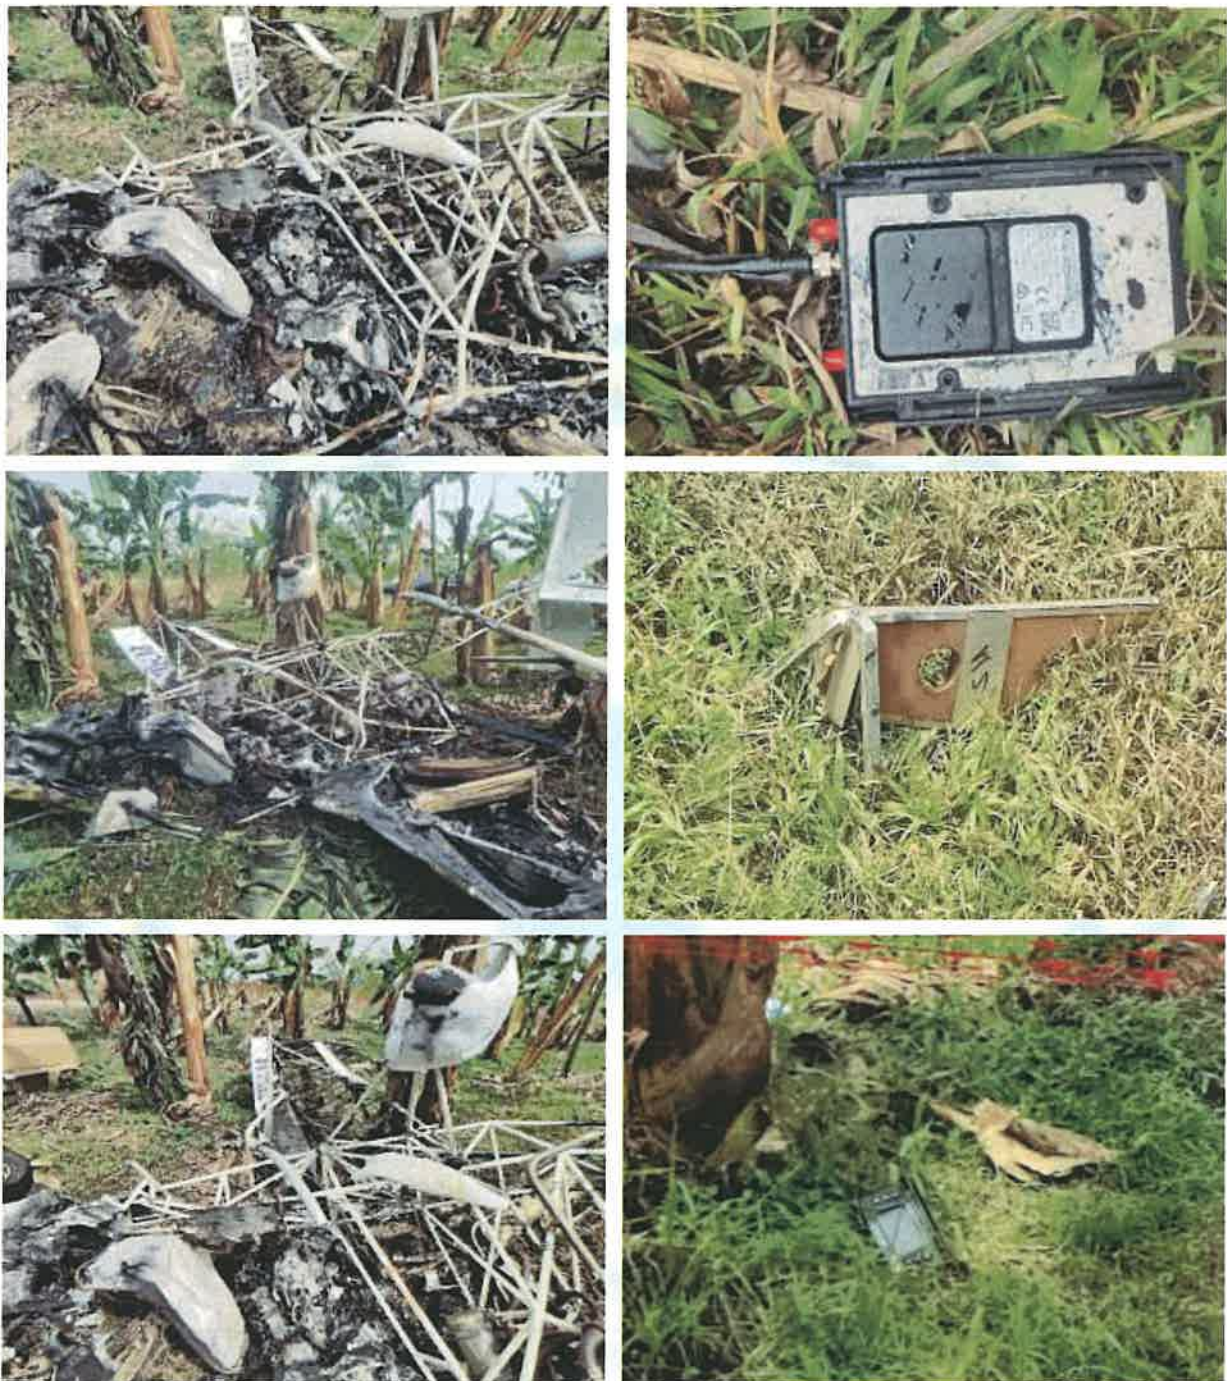
The wreckage was located on the North-Western border of Sector 22 of the banana plantation. The aircraft made contact with a power line running above the canopy of the plantation, flipped over and crashed upside down into the farm. The aircraft caught fire and was destroyed. The aircraft was found upside down, burned with some debris scattered around it. There was no evidence of a full head-on impact with the ground. There was no evidence of pre-crash failure and no evidence of fire prior to contact with the power line and the ground. Part of the windscreen, the GPS console and a rib from a wing were scattered approximately within a radius of 8 feet from the wreckage.

Figure 5: Photos of aircraft wreckage

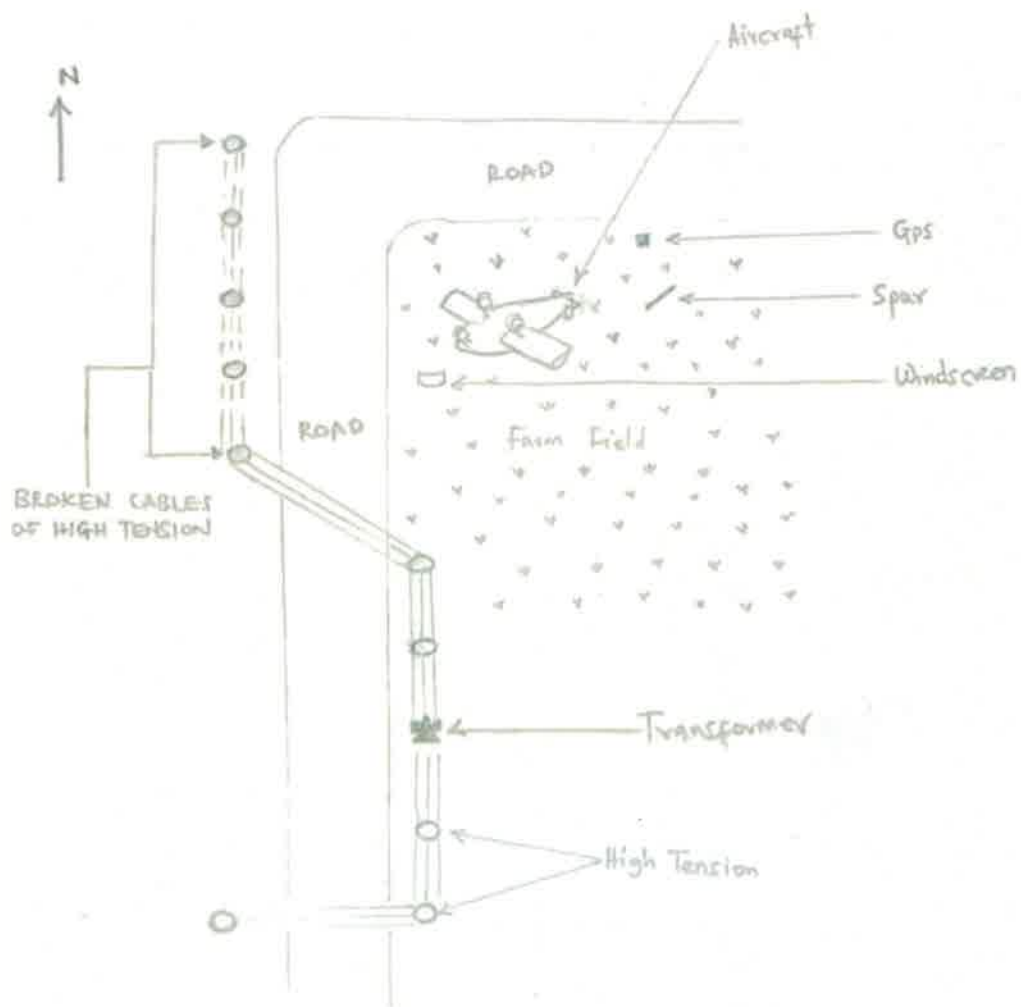
Figure 6: Wreckage Dispersal Diagram
