**AIRCRAFT ACCIDENT AND INCIDENT
INVESTIGATION AND PREVENTION BUREAU
(AIB GHANA)**

**REPORT ON CABIN DEPRESSURISATION
SERIOUS INCIDENT INVOLVING AFRICA
WORLD AIRLINES AIRCRAFT, 9G-AET**

2ND FEBRUARY 2024

**AIRCRAFT SERIOUS INCIDENT REPORT
AIB/2024/02/02/SINCID**

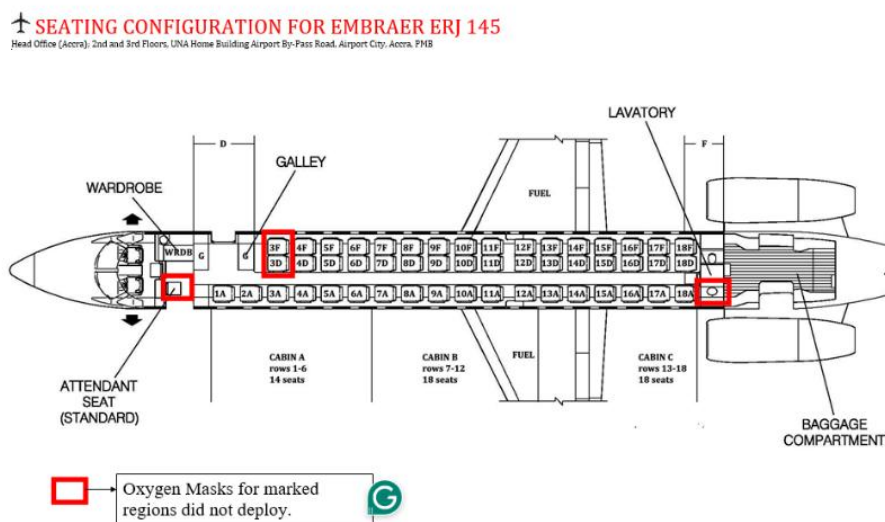
3.2.5. However, the masks at the forward cabin crew seat did not deploy and so the senior cabin crew used the one at seat 1A, but the mask at the forward cabin crew seat finally did deploy much later. Oxygen mask at seat 3D and 3F were half-hanging and could not be used. The affected passengers were swiftly moved to seat 17D and 18D. Also, the

Figure 4. Seating Configuration For Embraer ERJ 145 (Seats for which Oxygen Mask did not Deploy)

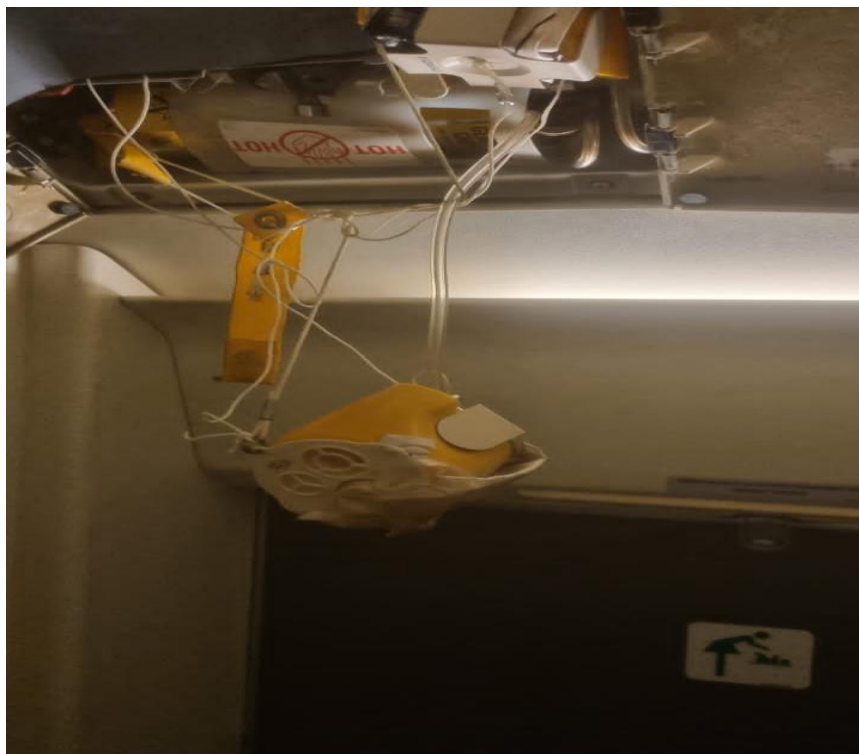
3.15.2. operational tests of the manual deployment systems have been successfully performed on the operating fleet and documented in FLB pages as indicated. All masks were inspected including the ones at 3D, 3F, and the lavatory, and found to be fully deployed.

Figure 6 : Deployed Lavatory Oxygen Mask

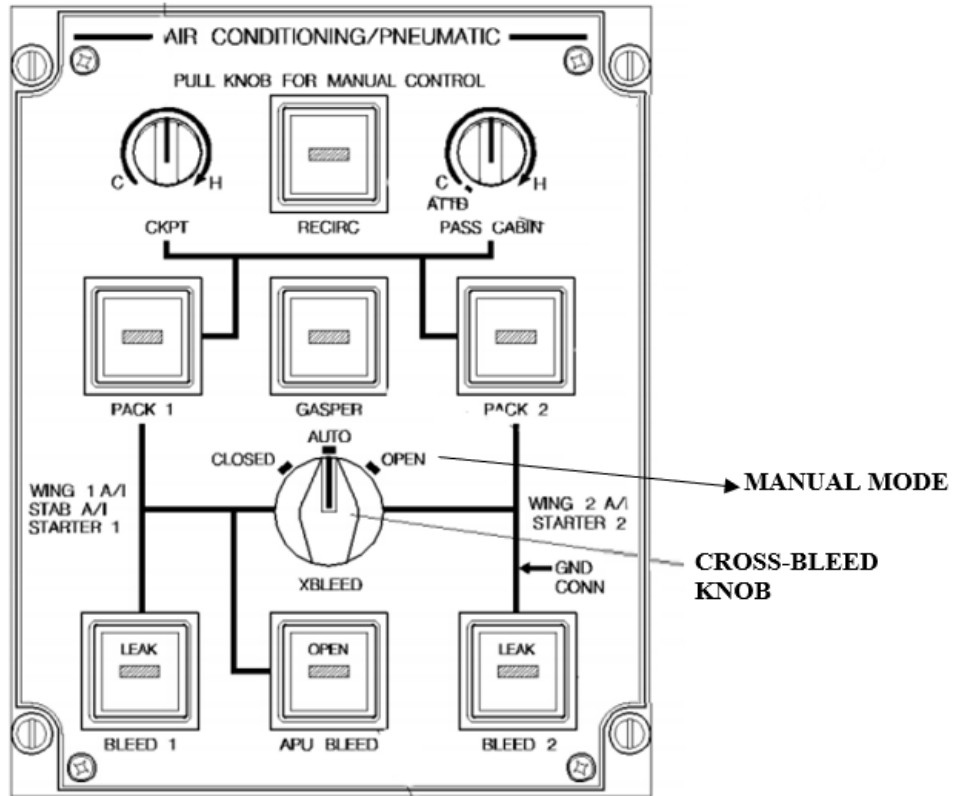
The operator submitted that, during the incident, the cross-bleed valve was in automatic mode, and as a result, bleed air from the bleed #1 valve could not reach Pack #2 to pressurise the cabin. This could have been done by selecting OPEN using the Cross-bleed knob to allow the Cross-bleed valve to receive air flow to Pack #2 directly.

Figure 7 : Air Conditioning / Pneumatic Control Knob
