**AIRCRAFT ACCIDENT AND INCIDENT  
INVESTIGATION AND PREVENTION BUREAU  
(AIB GHANA)**

**FINAL REPORT ON ACCIDENT INVOLVING SKY  
ARROW 650T MICROLIGHT AIRCRAFT  
REGISTRATION 9G-ADV, WHICH OCCURRED AT  
COMMUNITY 1, TEMA**

**16<sup>TH</sup> MARCH, 2026.**

**FINAL AIRCRAFT ACCIDENT REPORT  
AIB/2026/03/16/ACCID**

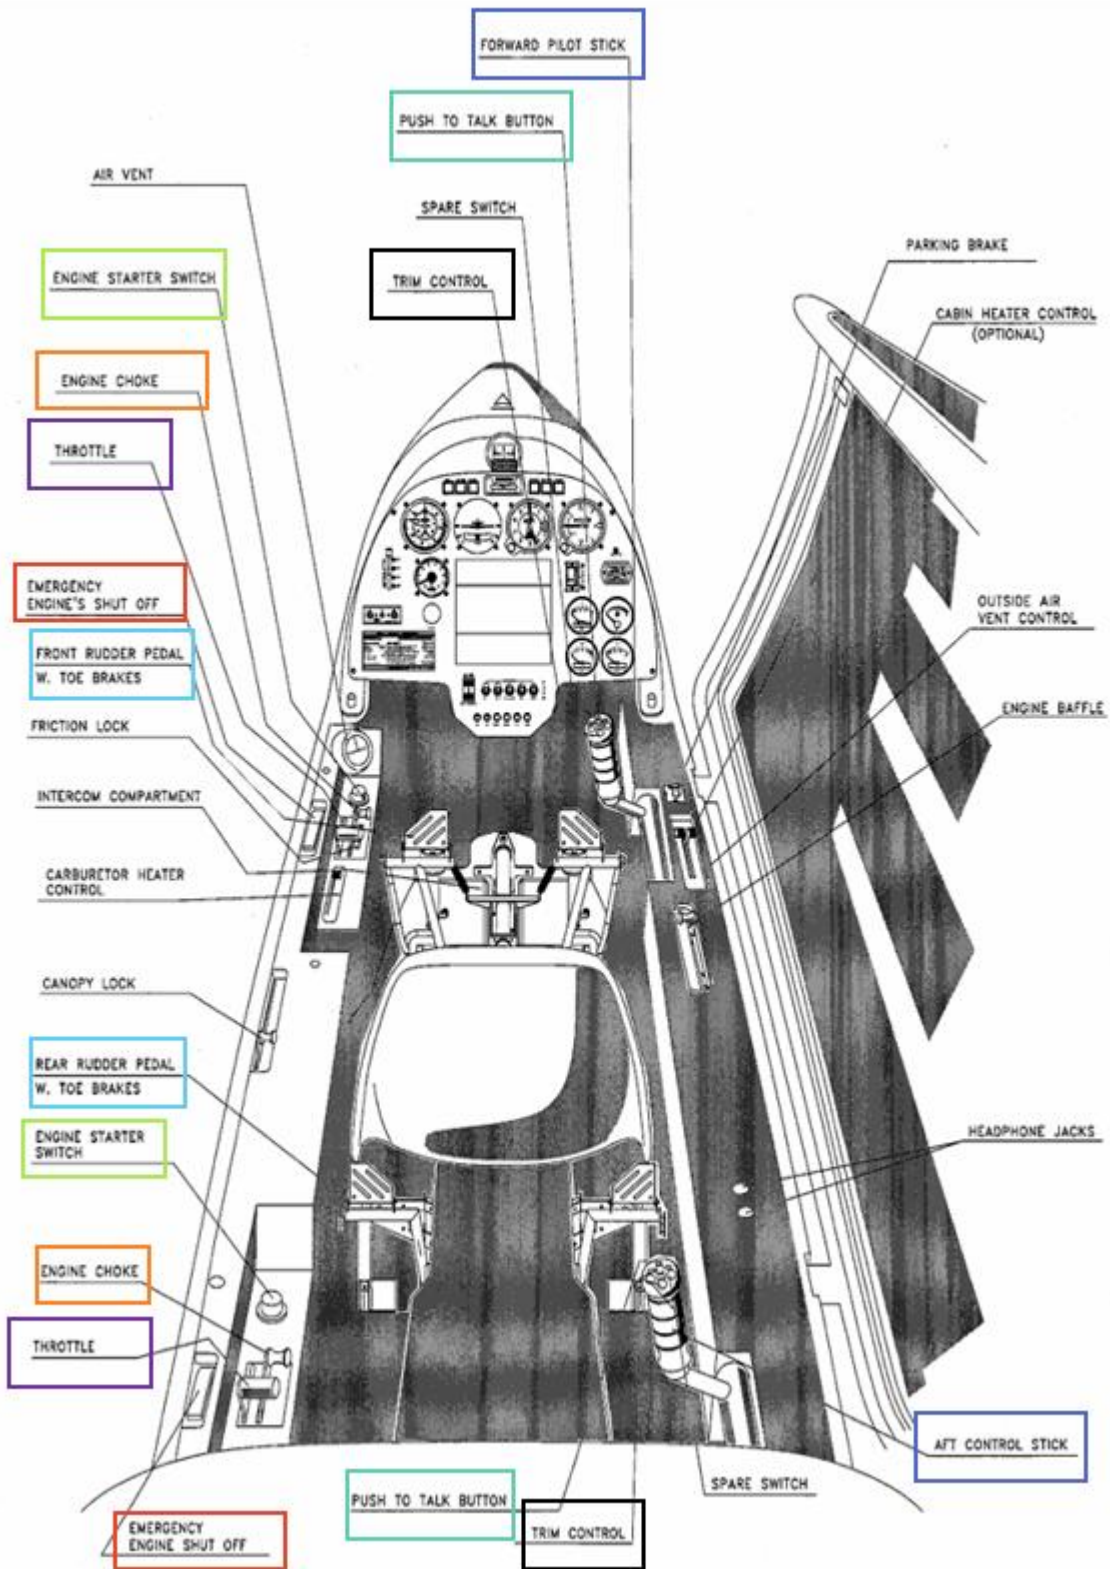
FIG 1: AIRCRAFT DUAL CONTROLS SCHEMATIC

The aircraft was equipped with dual control sticks, dual rudder pedals and dual throttle control as indicated in Fig 1. The flight and engine instruments were located on the forward instrument panel in the cockpit. Though the rear seat was elevated, its occupant was denied the full access to switches and instrumentation required for the operation of the aircraft especially in emergencies.

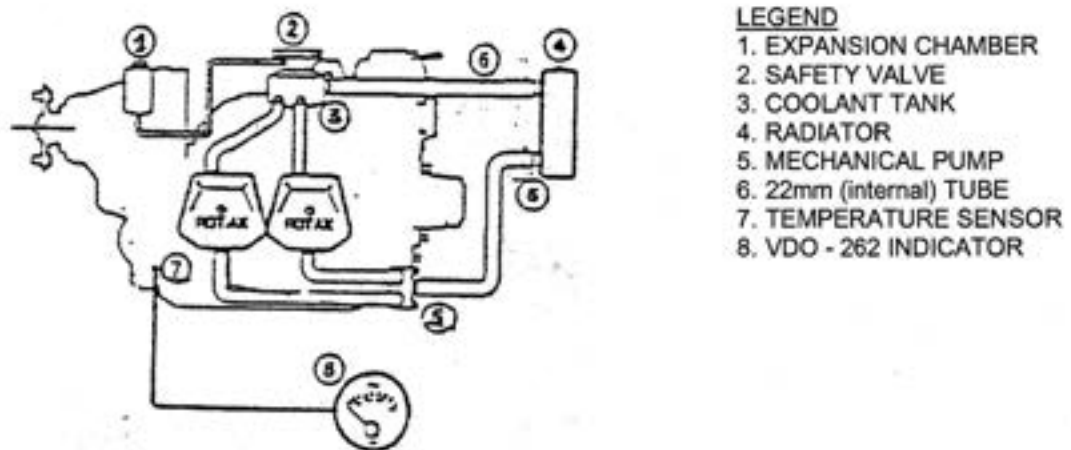
FIG 2: ENGINE COOLING SYSTEM SCHEMATIC

The front air intake on the engine cowling guarantees the necessary air to cool the oil and coolant radiators and to cool the cylinders and the feed through-filters of the two carburetors. On the lower side of the engine nacelle, there are two dynamic air ports to cool the exhaust compartment. Hot air escapes through two vents on the lower back side of the nacelle and it is made easier by the suction created by the turning propeller. Cooling of the cylinder heads is accomplished by the circulation of the coolant caused by an engine operated pump. The coolant quantity can be checked by means of level notches on the reservoir. The cooling radiator is mounted in the lower side of the front air intake inside the engine cowling. A schematic of the system is showed in Fig 2.

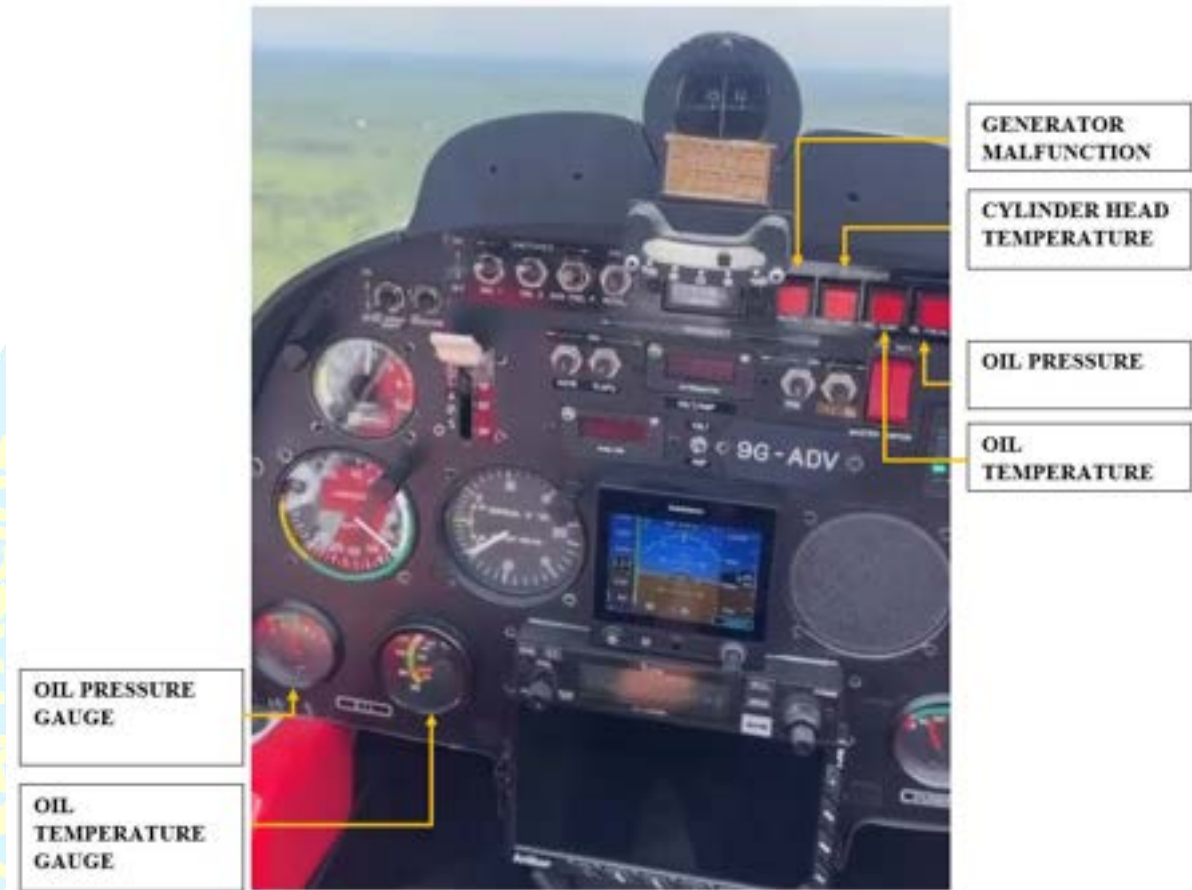
FIG 3: INSTRUMENT PANEL LAYOUT - CONFIGURATION

The standard model is equipped with red warning lights that signal when the oil pressure, oil temperature and cylinder heads temperature (CHT) have reached dangerous levels or when the generator is not supplying enough energy. Location of the warning lights on the instrument

panel is illustrated in Fig 3. The alarms operate at the following limits: oil temperature oil pressure cylinder heads temperature (CHT) generator output > 266 °F + 9 °F (>130 °C + < 22 psi (1.5 bar) > 266 °F + 9 °F (> 130 °C + 5 °C) 5 °C) < 12V
