**AIRCRAFT ACCIDENT AND INCIDENT  
INVESTIGATION AND PREVENTION BUREAU  
(AIB GHANA)**

**AIRCRAFT INCIDENT REPORT  
AIB/2021/09/03/INCID**

**REPORT ON THE BIRD STRIKE INCIDENT  
INVOLVING KLM FLIGHT KL 590 BOEING 777-300 ER  
AIRCRAFT WITH REGISTRATION PH-BVK ON 3<sup>RD</sup>  
SEPTEMBER, 2021 AT KOTOKA INTERNATIONAL  
AIRPORT, ACCRA, GHANA.**

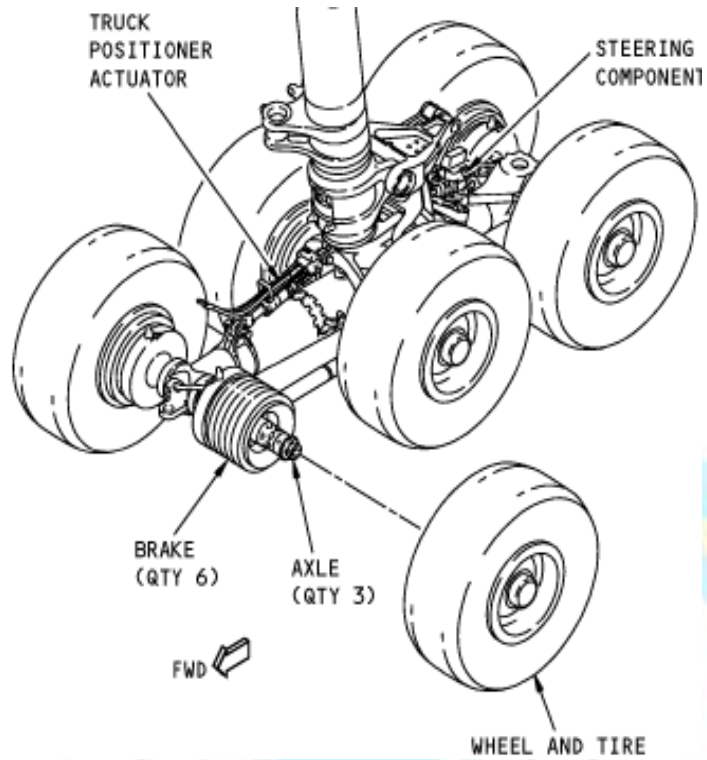
Figure 1 B777-300 ER Brake Unit

The B777-300ER has two main landing gear assemblies and a single nose gear assembly. Each main landing gear has six wheels in tandem pairs and six brake units. The nose gear is a conventional two-wheel assembly without brake units.

Three thermal release plugs in the inner half of each main gear wheel prevent tyre explosion caused by hot brakes. The plugs melt to release tyre pressure when temperature is approximately 199°C.

High energy stop inspection was performed, axles and brakes were found to be satisfactory. Wheel numbers 3, 8, 10 and 11 were replaced followed by an independent inspection (*Appendix D*).

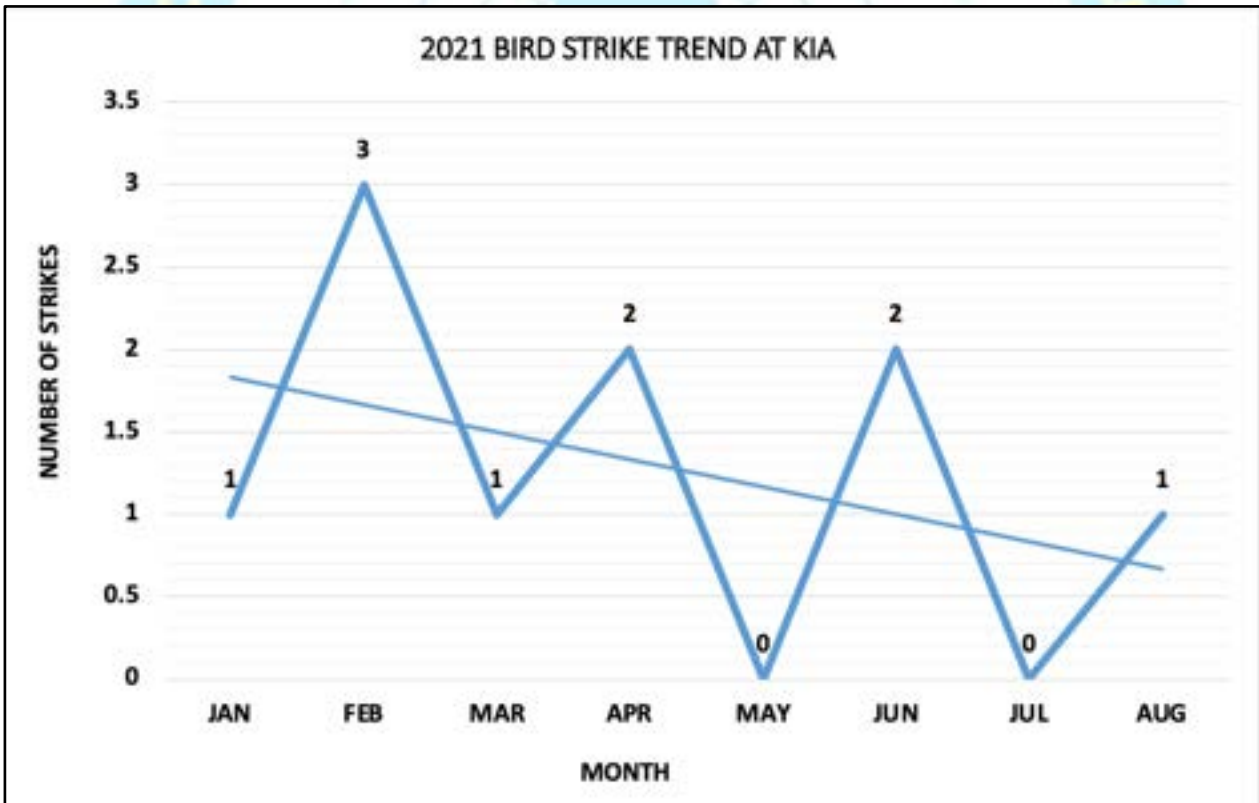
Figure 5 Bird Strike Trend at KIA - 2021

Most bird strikes at KIA occur during the day. However, the Lapwing is known to feed at night and was the type of bird involved in the incident of the night of 3<sup>rd</sup> September, 2021.

- A. GACL should intensify coordination with stakeholders concerning Bird and Wildlife Hazard Management.
- B. GACL should increase wildlife mitigation procedures especially during the peak hours of operations.
- C. ATS/ANS should consider the establishment of a discrete frequency between flight crew and RFFS with its appropriate protocols.
