**AIRCRAFT ACCIDENT AND INCIDENT  
INVESTIGATION AND PREVENTION BUREAU  
(AIB GHANA)**

**REPORT ON ACCIDENT INVOLVING TRAVAUX ET  
SERVICES AERIENNES (TSA), HUMBER AVIATION  
M.D.C. 912 STA AIRCRAFT WITH REGISTRATION  
TU-LAB, AT KASUNYA - ASUTSUARE (EASTERN  
REGION) ON 17 MARCH 2022.**

**AIRCRAFT ACCIDENT REPORT  
AIB/2022/03/17/ACCID**

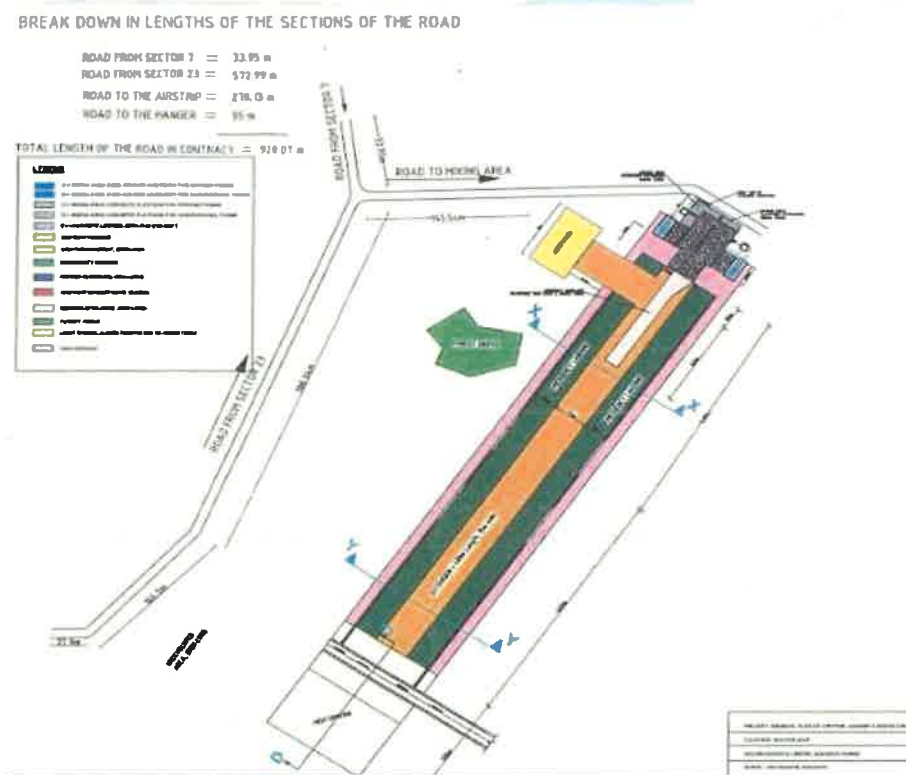
Figure 3: Kasunya Airstrip Information

The Kasunya airstrip (6° 3' 0" North, 0° 16' 0" East), is an uncontrolled airport situated in Yilo-Krobo-Osudoku, Eastern Region. It is an Agricultural Ultralight Airfield belonging to GEL purposely for the spraying of its banana plantation. The airstrip has one runway which is oriented East/West (Runway 10/28), 300m long and 10m wide. The runway is a compacted laterite surface with a flat slope.

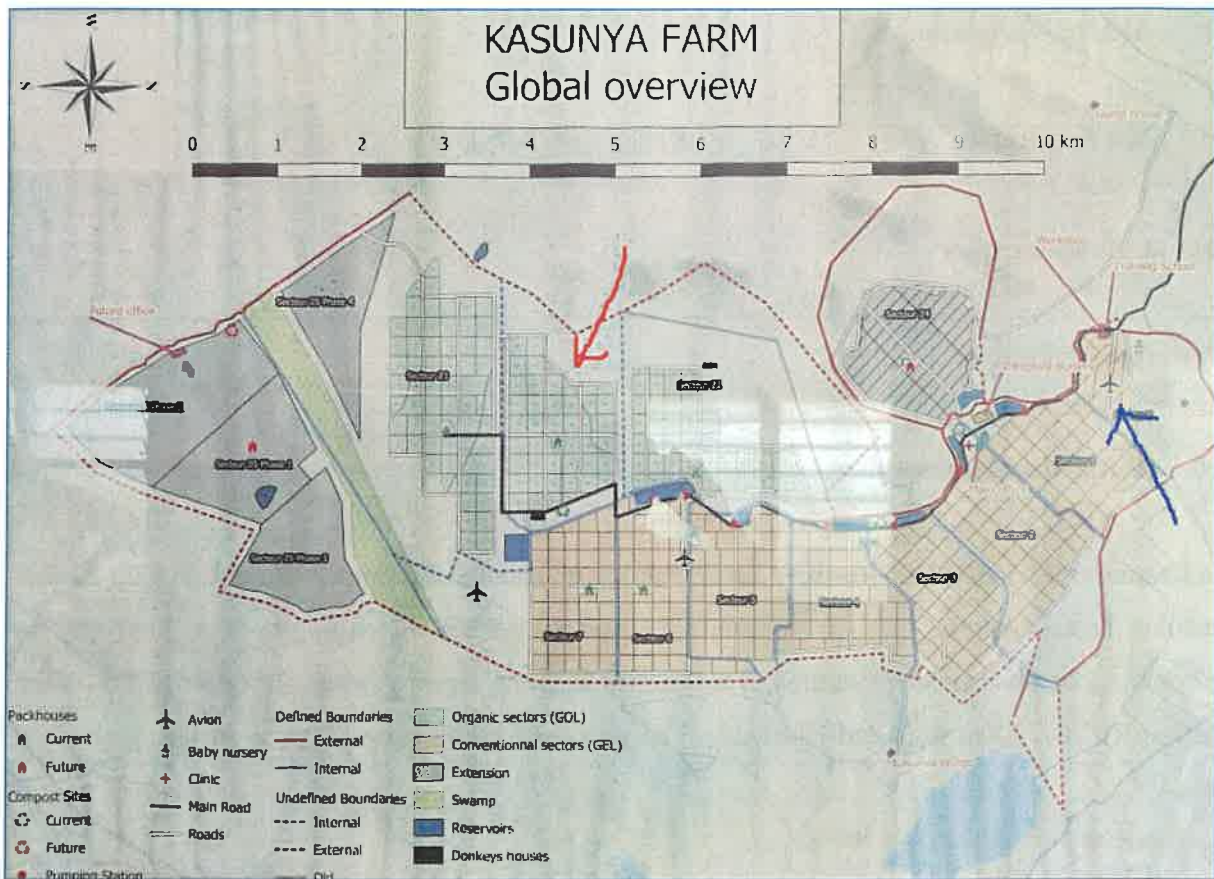
Figure 4: Aerial Map of Kasunya Farm (Red Arrow-Sector 22/Blue Arrow-Runway)

The wreckage was located on the North-Western border of Sector 22 of the banana plantation. The aircraft made contact with a power line running above the canopy of the plantation, flipped over and crashed upside down into the farm. The aircraft caught fire and was destroyed. The aircraft was found upside down, burned with some debris scattered around it. There was no evidence of a full head-on impact with the ground. There was no evidence of pre-crash failure and no evidence of fire prior to contact with the power line and the ground. Part of the windscreen, the GPS console and a rib from a wing were scattered approximately within a radius of 8 feet from the wreckage.
